RADC-TR-79-220

In-House Report

July 1979

POSITIONAL ERROR ANALYSIS, A-10 AIRCRAFT ON THREE-AXIS GROUND MOUNT

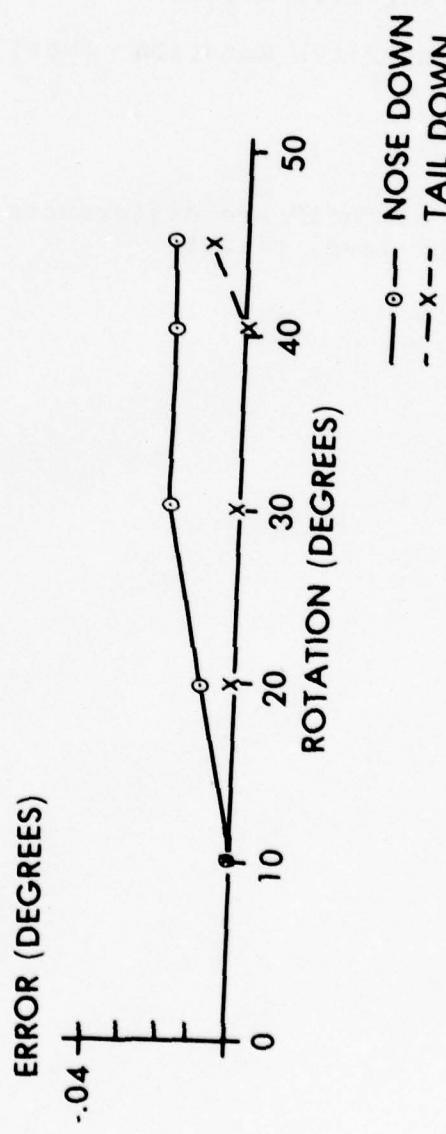
FIGURE 1A OBSERVED ERROR FOR PITCH TEST (28 OCTOBER 1977)
 VS
 PITCH ROTATION
 AIRCRAFT UPSIDE DOWN

* ERROR IS DEFINED AS THE CHANGE IN SYNCHRO READOUT MINUS THE CHANGE IN ANGLE DETERMINED FROM INCLINOMETER READOUT

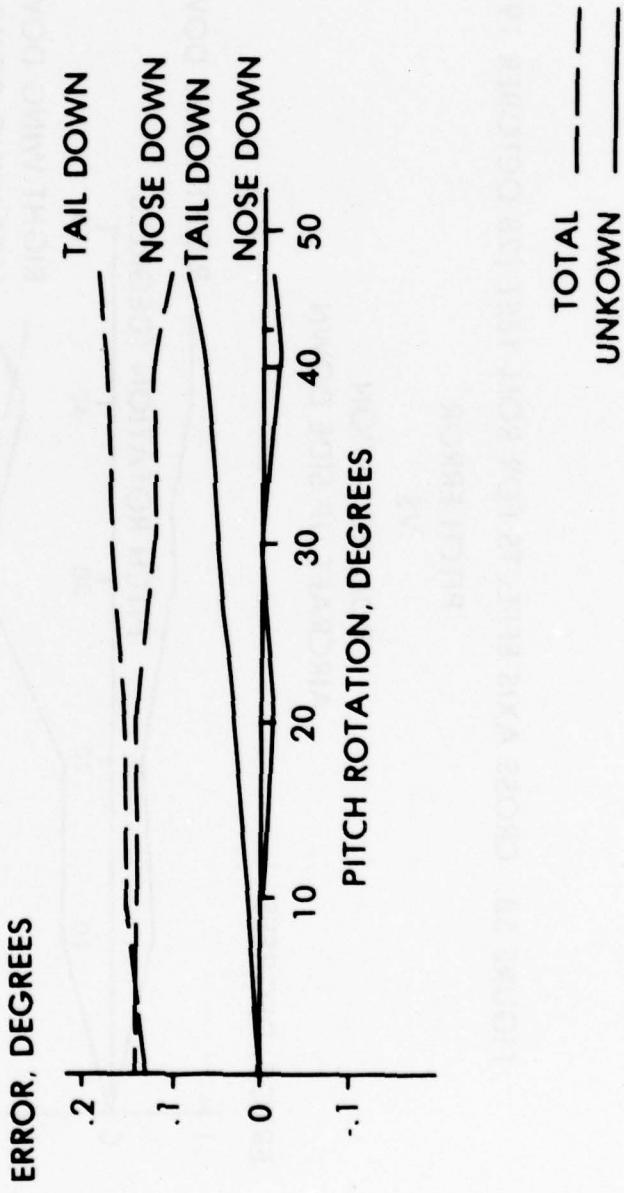
FIGURE 4B. CROSS AXIS EFFECTS FOR ROLL TEST (31 MARCH 1978)

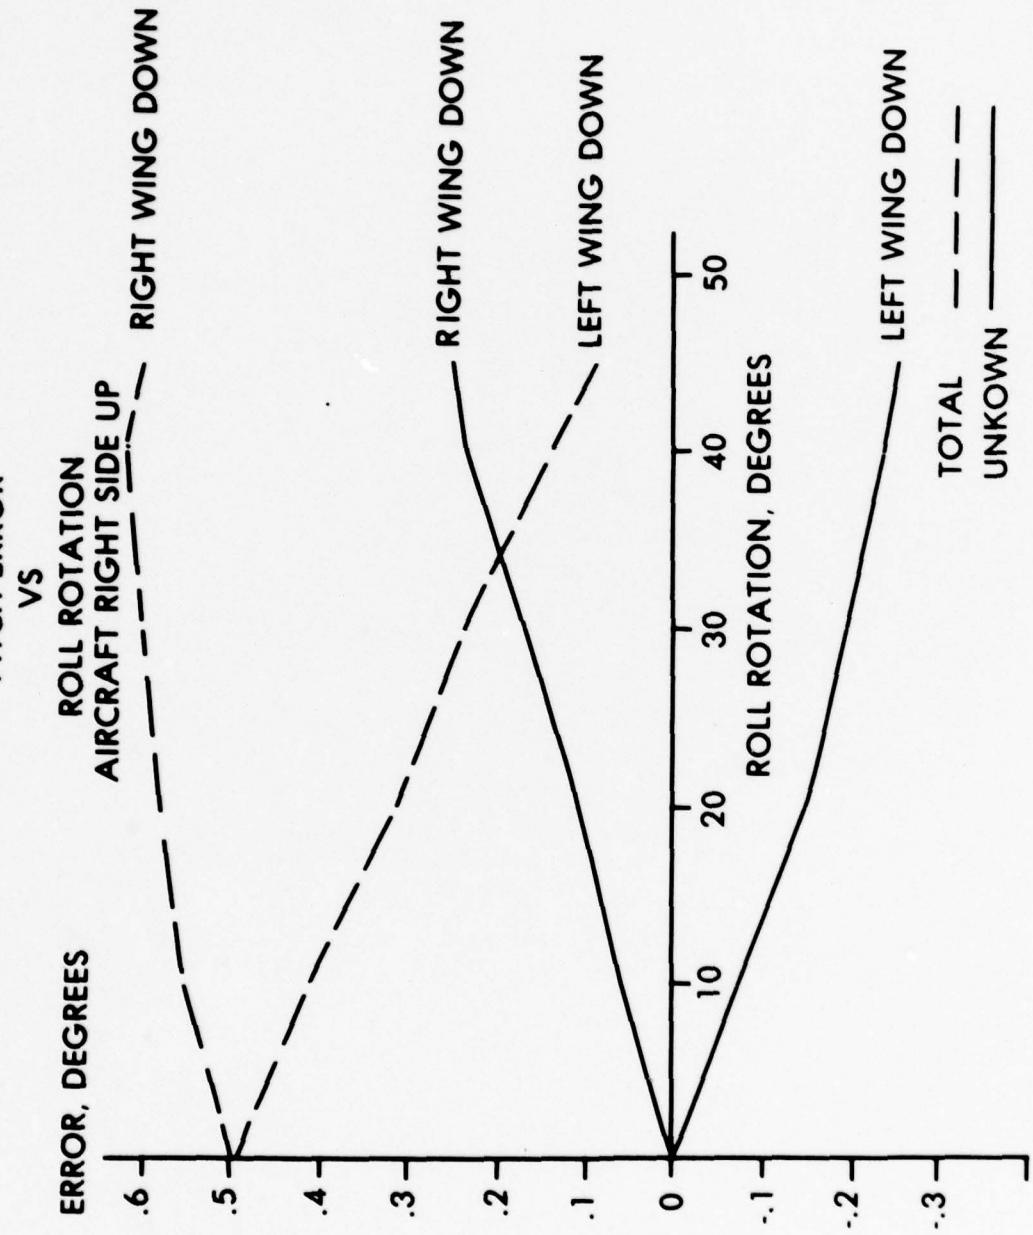
The maximum cross-axis motion observed was 0.614 degrees of pitch motion occurring during a 40 degree right wing down roll motion with the aircraft right side up. This value includes the effect of initial out-of-level. With this effect eliminated from the data, the remaining motion is 0.230 degrees. The maximum cross-axis pitch error remaining after removal of initial out-of-level effects was 0.257 degrees of pitch motion occurring during a 45 degree left wing down roll rotation with the aircraft right side up.

Cross-axis errors occurring during the roll tests are substantially greater than during pitch tests, for both total errors, and errors due to unknown causes. Cross-axis errors due

to unknown causes during roll tests tend to increase in a somewhat linear manner with increasing roll angle, and are larger for the right side up orientation of the aircraft. For pitch tests, the errors are very small for the nose down case, i.e., less than 0.02 degrees. For the tail down case, they increase to almost 0.1 degree.

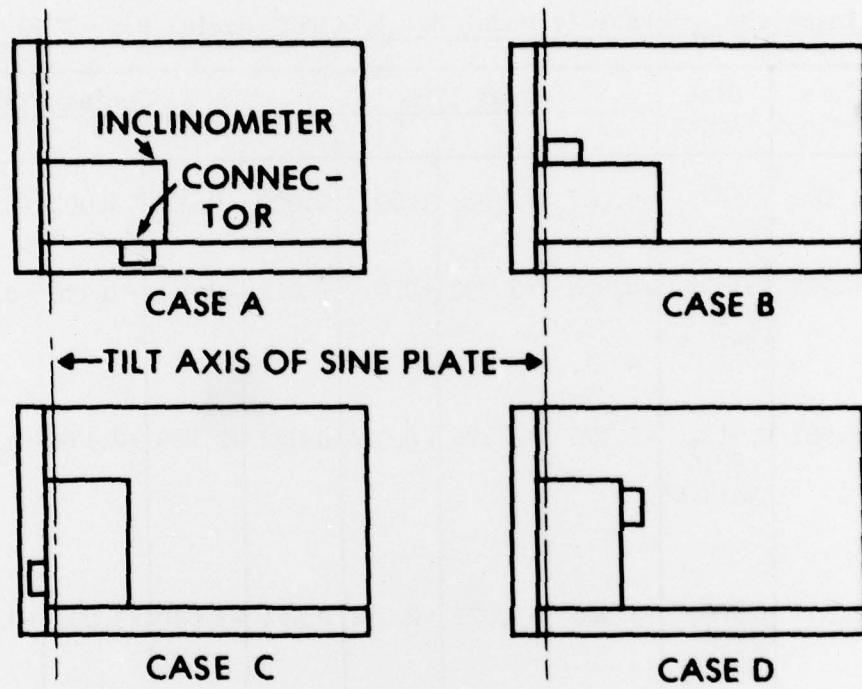
FIGURE B1 INCLINOMETER CALIBRATION

1. Maximum inclinometer error can approach 0.15 degrees for large rotations about the sensitive axis.
2. Rotations about the nonsensitive axis produce voltage readings greatly in excess of those predicted by the manufacturer.
3. It is recommended that inclinometers serials 1790 and 1791 be returned to the manufacturer for complete recalibration

and to determine the reason for the drastic nonsensitive axis increase in output.

4. Inclinometers should be recalibrated about both axes prior to the start of each major test program. Means should be developed to permit periodic rechecks between calibrations to insure that reinstallation of inclinometers after such things as changes in aircraft orientation does not result in inclinometer performance degradation.

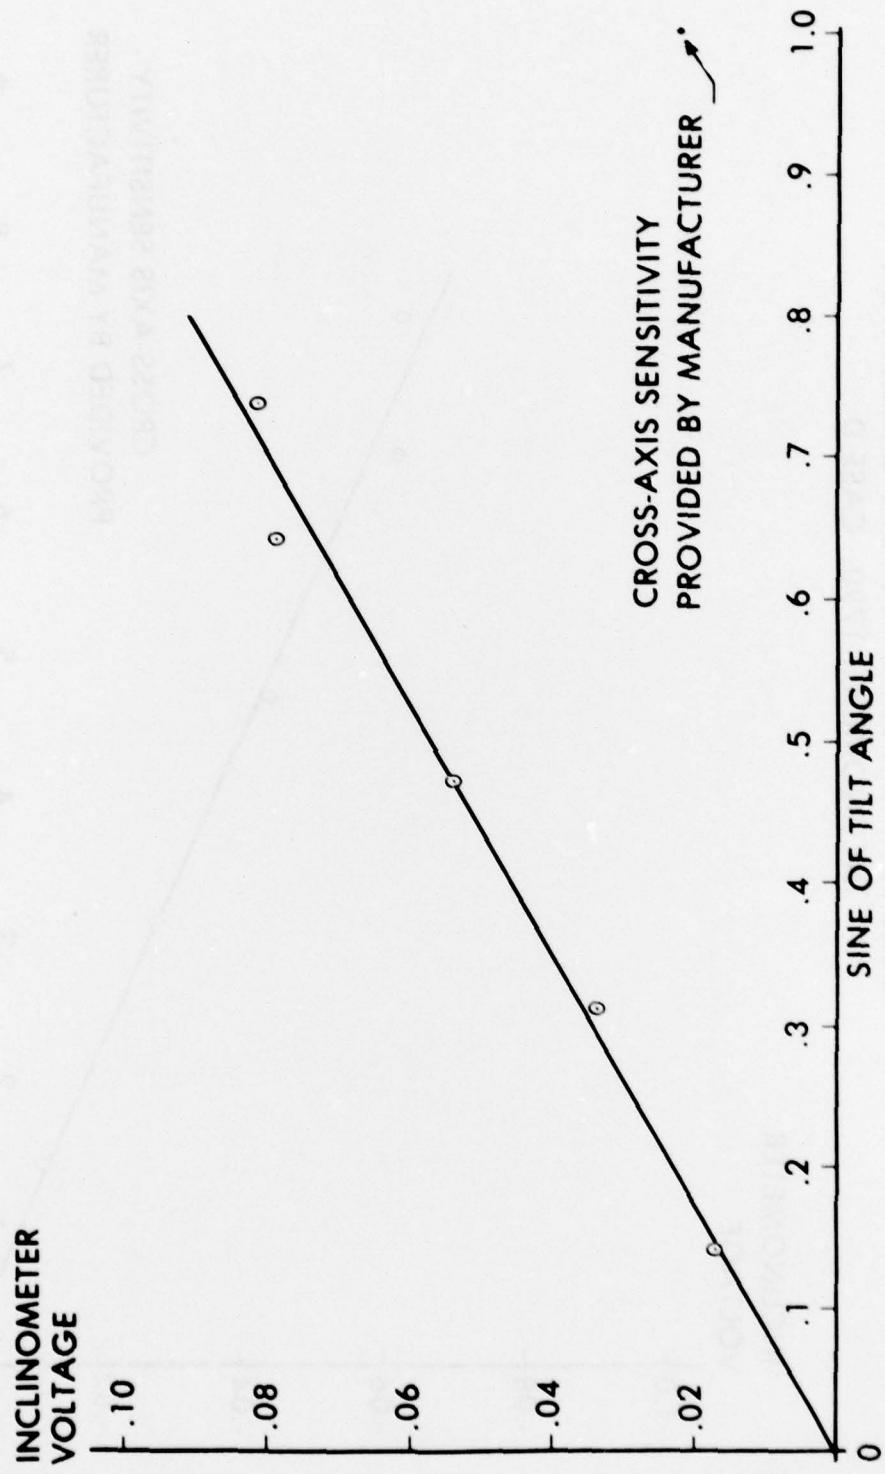
Cross-axis sensitivity observed in the calibration substantially exceeded that stated by the manufacturer. For Serial Number 1790, Table No. 1 shows a cross-axis sensitivity value of 0.023

FIGURE B2. NON-SENSITIVE AXIS CALIBRATION
INCLINOMETER 1790. CASE C

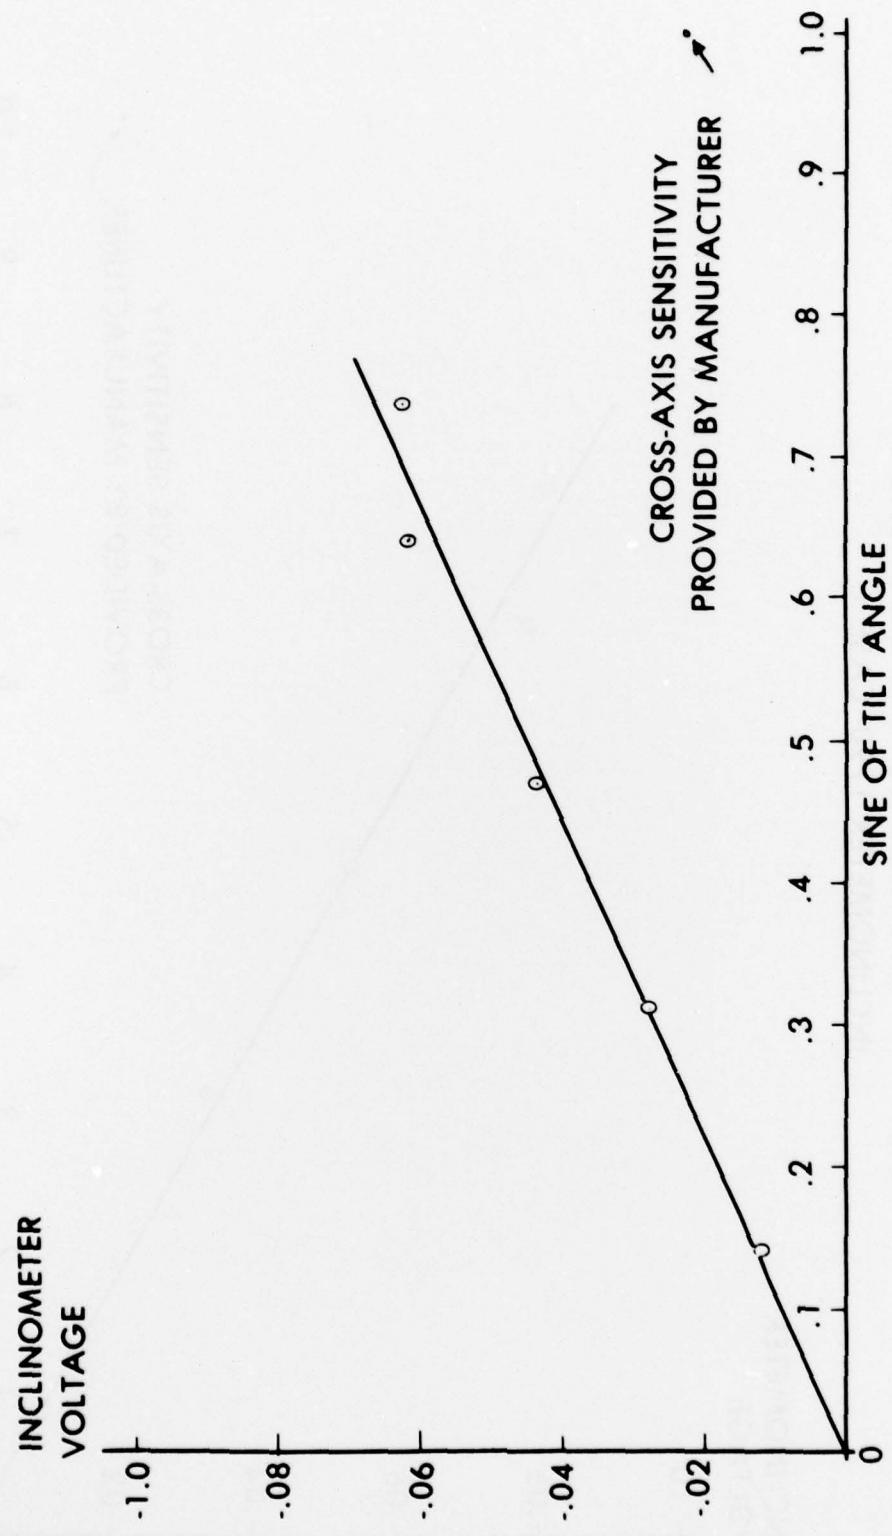
FIGURE B3. NON-SENSITIVE AXIS CALIBRATION
INCLINOMETER 1790- CASE D

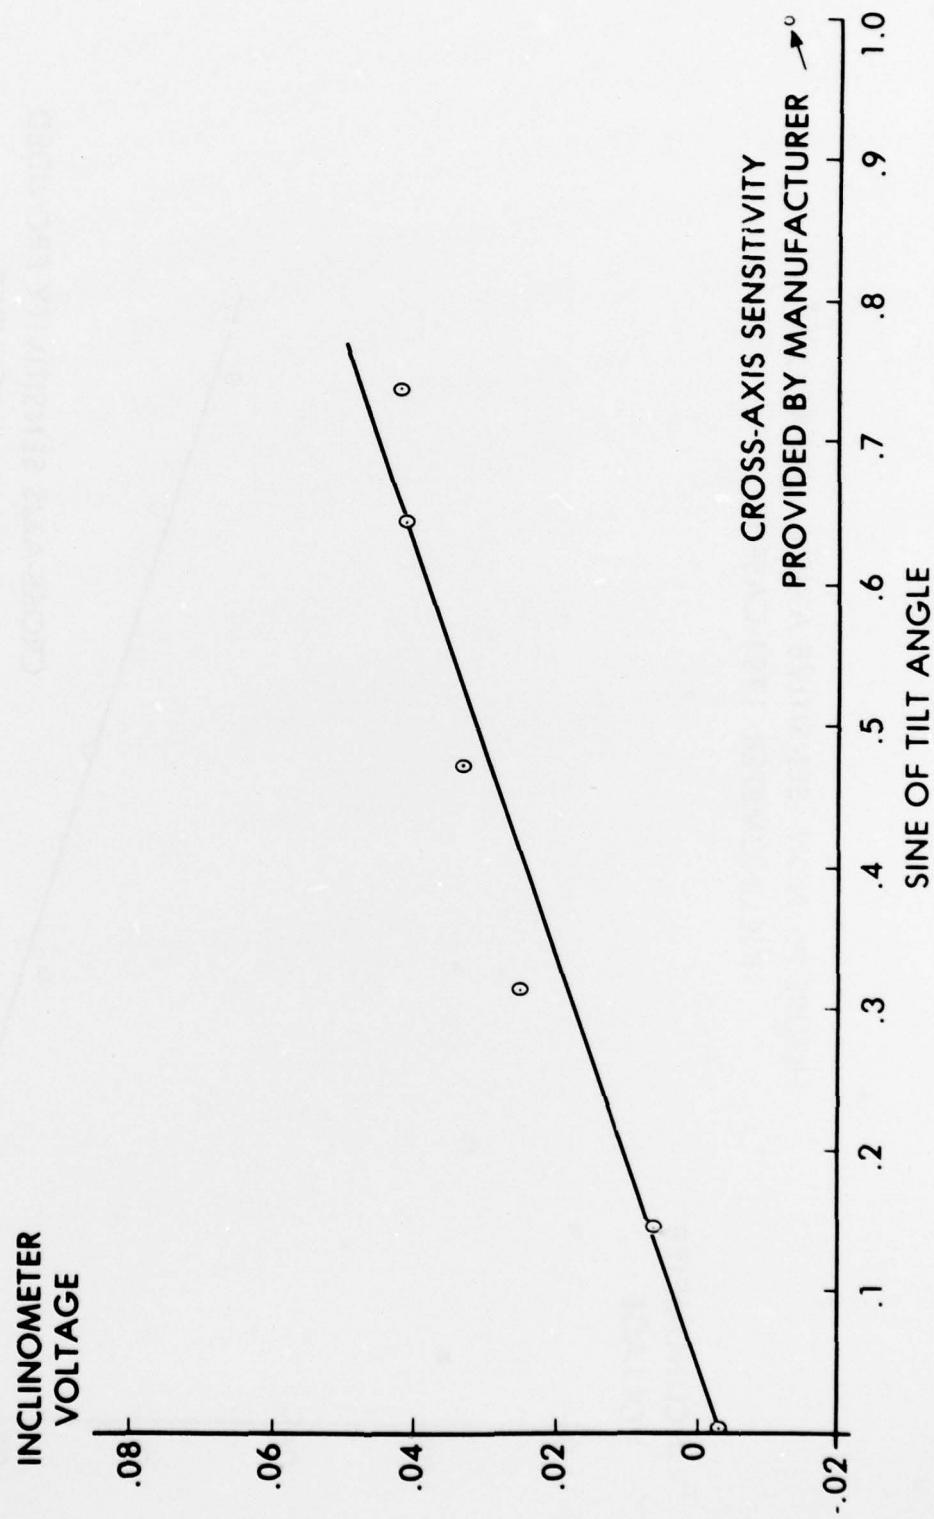
FIGURE B4. NON-SENSITIVE AXIS CALIBRATION
INCLINOMETER 1791-CASE C

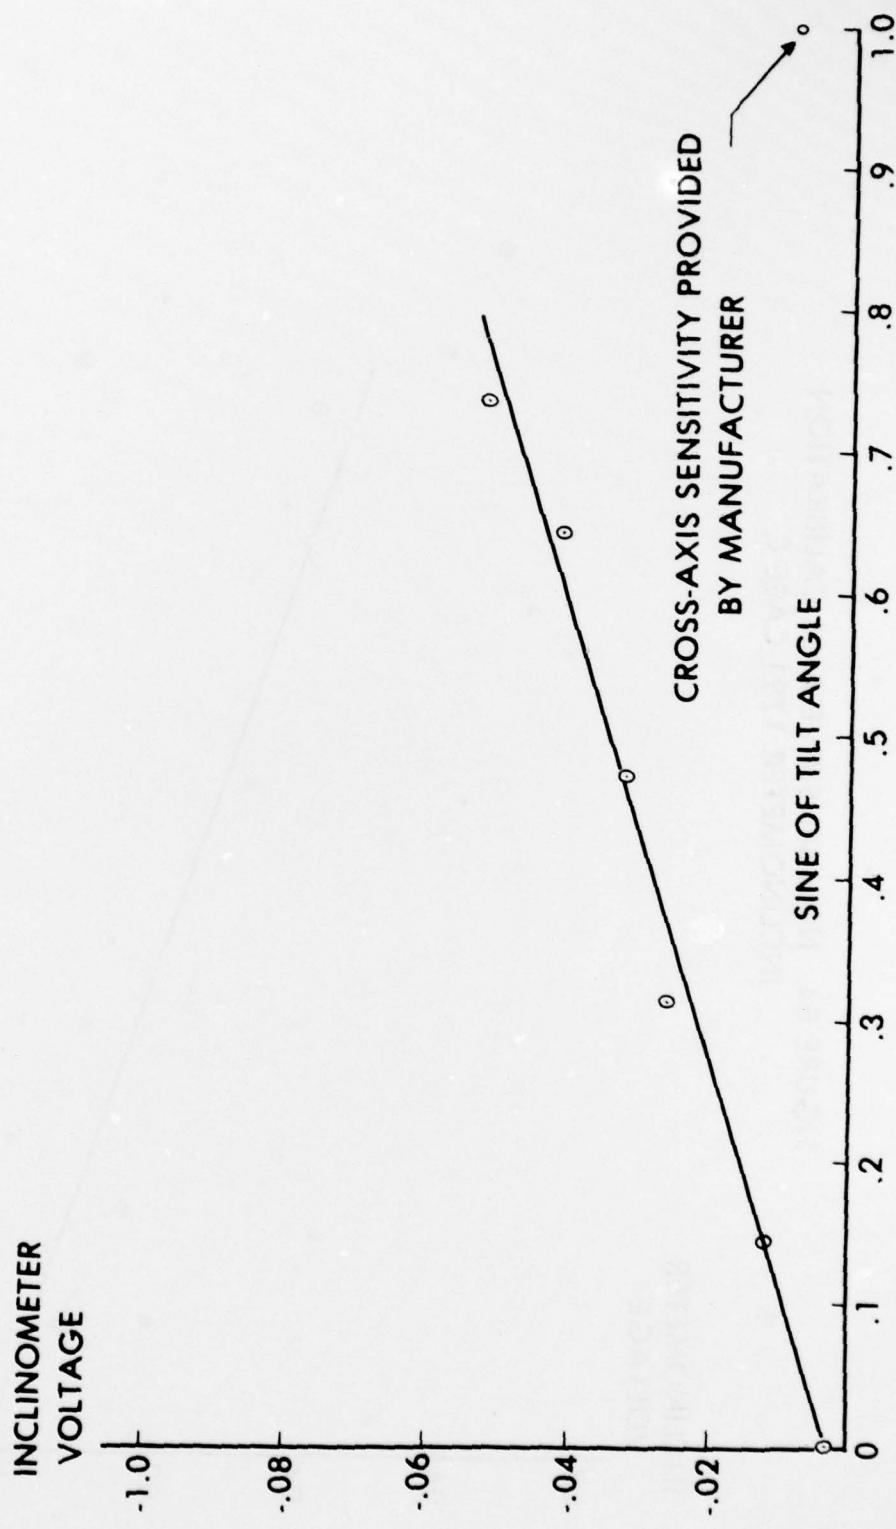
FIGURE B5 NON-SENSITIVE AXIS CALIBRATION
INCLINOMETER 1791-CASE D
